Application Note R537

Raman-Troubleshooting and Failure Analysis of precision mechanics

Small Components, Smaller Defects

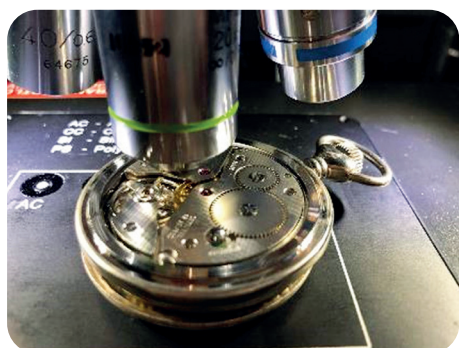
Figure 1: Clock without cover glass under the 20x objective on the SENTERRA II sample stage. Cover glass was removed to improve visual inspection.

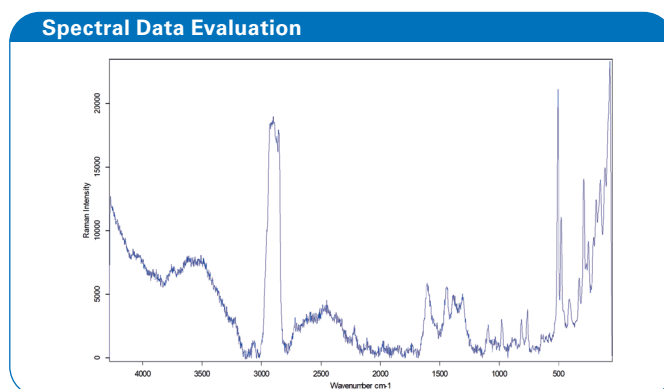
Although the visual data gave first hints on the defects nature, yet only a chemical analysis by Raman would yield the whole picture. The dark residue on the cogwheel and teeth edges showed distinct signals of aliphatic hydrocarbons, most likely a lubricant or anti-corrosive sealant (Figure 3).

Figure 3: Spectrum of the residue on the metallic cogwheel. The C-H bands around 2900 cm^{-1} indicate grease or oil, most likely a lubricant.

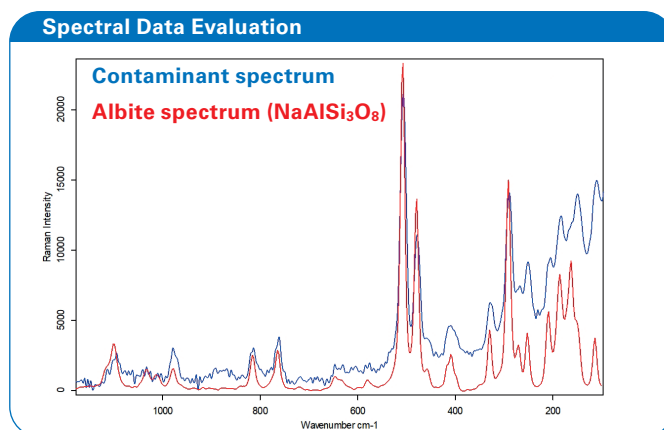
The residue's Raman spectra also revealed bands typical for inorganic material (below 1200 cm^{-1}). Upon closer inspection and after a successful reference library comparison, the unknown signals were identified as albite (Figure 4). This common silicate can be found around the world and has a Mohs hardness of 6–6.5.

The lubricant was suspected to be contaminated by small particles of albite. The then occurring degradation led to the failure of delicate machinery. During the review of the respective lubricant batch, the suspicion was conclusively confirmed and the defective batch disposed of quickly.

Figure 4: Contamination spectrum in the range of 1200 to 100 cm^{-1} (blue). The lubricant apparently contains albite (red), a silicate mineral.
