# Application News

## No. A503

## Quality Analysis of Environmental Water

- Using a Water Analysis Program Designed for the UV-1280 -

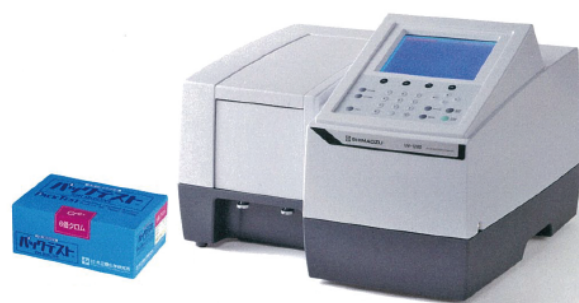
Fig. 1 UV-1280 and PACKTEST

The UV-1280 and a Kyoritsu Chemical-Check Lab., Corp. PACKTEST are shown in Fig. 1. The water analysis program displays the measurement procedure on-screen. An example procedure is shown in Fig. 2. The program also has built-in calibration curves created with standard samples, so concentration measurements can be made simply by following the on-screen instructions. New measurement items can also be added using a User-Defined Items function, and a trend graphing function can be used to show day-to-day changes in a single view.

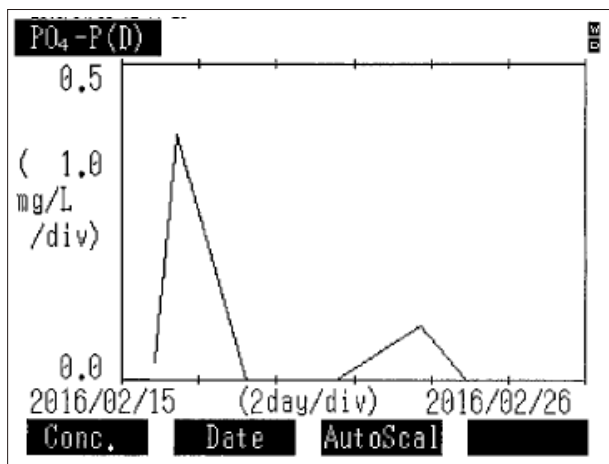
Fig. 3 Phosphate Phosphorus over Time (Trend Graph)

The trend graph shown in Fig. 3 allows the user to understand day-to-day changes in the phosphate phosphorus concentration in river water A at a single glance. The phosphate phosphorus concentration was below the lower limit of detection (0.04 mg/L) on most days, while a maximum concentration of 0.398 mg/L was detected on February 16. Rainfall was observed close to the river water collection point on February 14 and 20, which probably caused the low levels of phosphate phosphorus detected on February 15, 16, and 22.

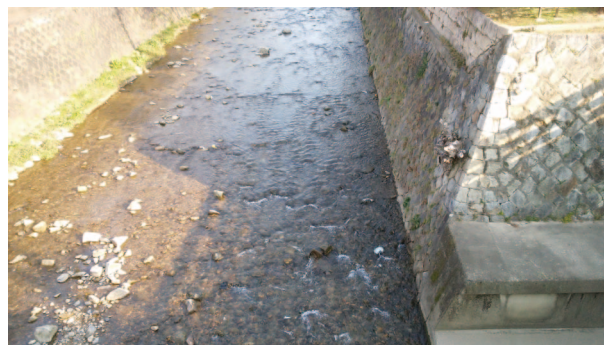
Fig. 4 River at Collection Point

A photograph of the river water collection point is shown in Fig. 4. The photograph shows the water was clean and the riverbed was fully visible on sunny days.
