Agilent 8860 GC

Firmware Bulletin

Revision 2.2.2.4

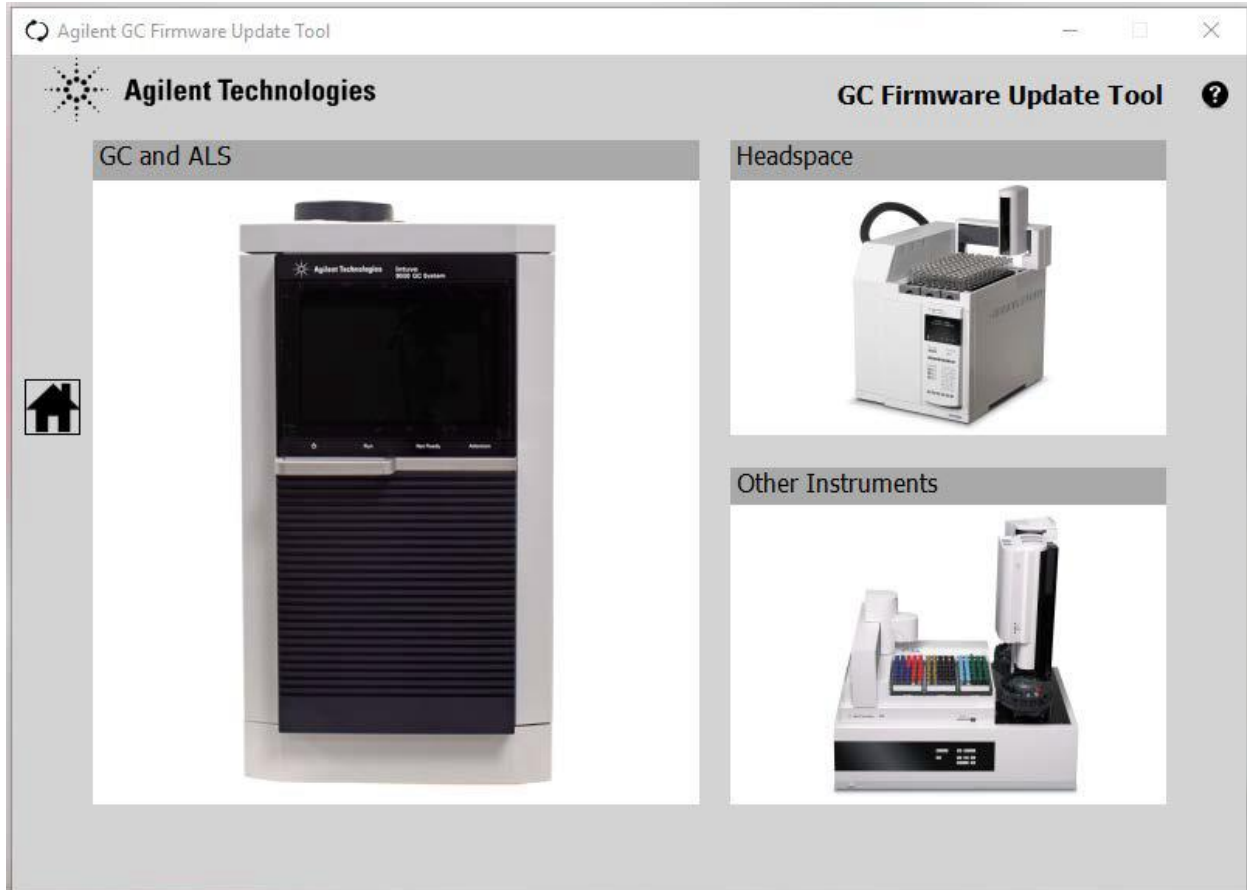
After the program has been loaded and executed the following screen appears.

This enables the user to select which instrument type needs to have its firmware downloaded. In this case we select the GC and ALS.

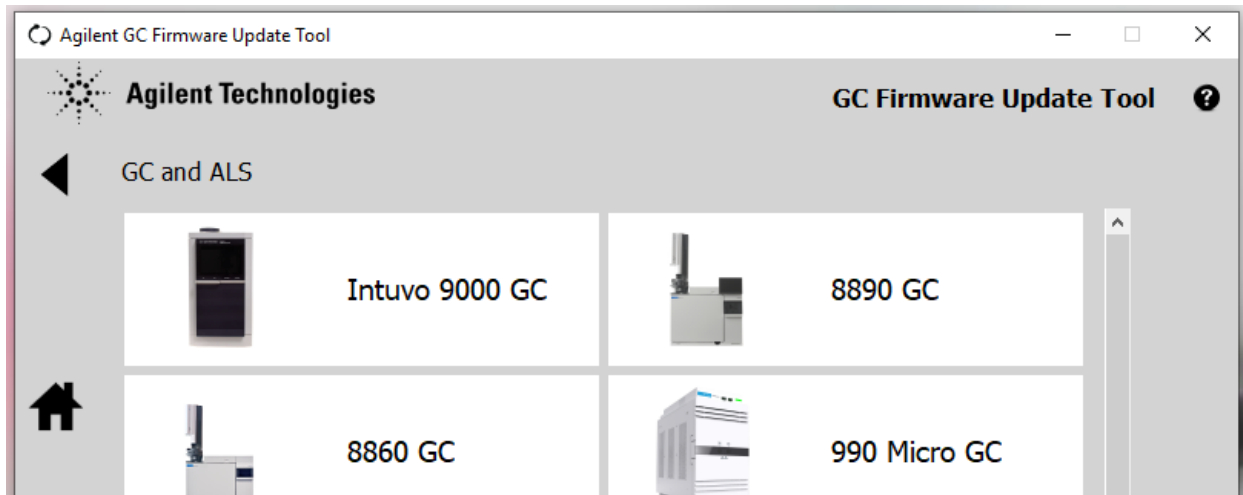
The **8860 GC** is chosen from the Product menu.

The next screen allows us to either modify firmware or PID values for the EPC modules.

Firmware update is selected.

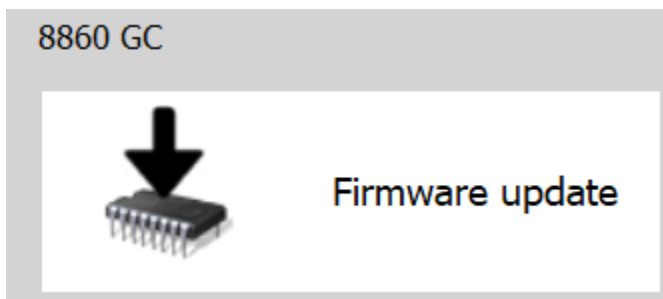
After choosing to update firmware, you must then enter the IP address of the 8860 GC that you wish to connect to and then press **Connect**.

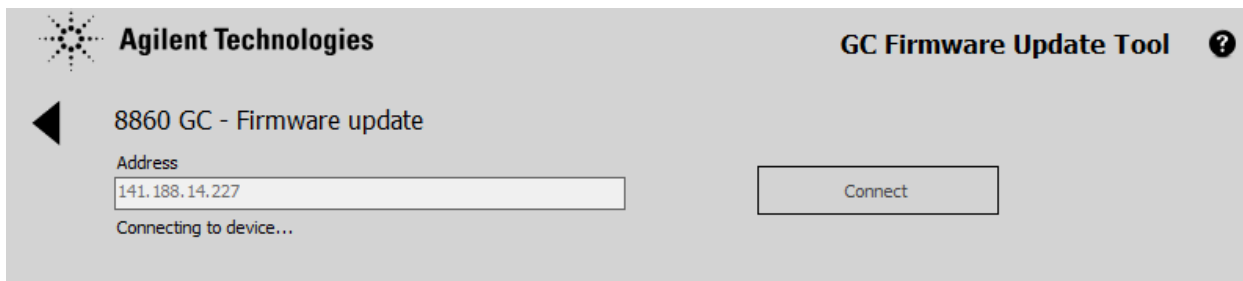
Information such as current installed firmware will then be displayed.

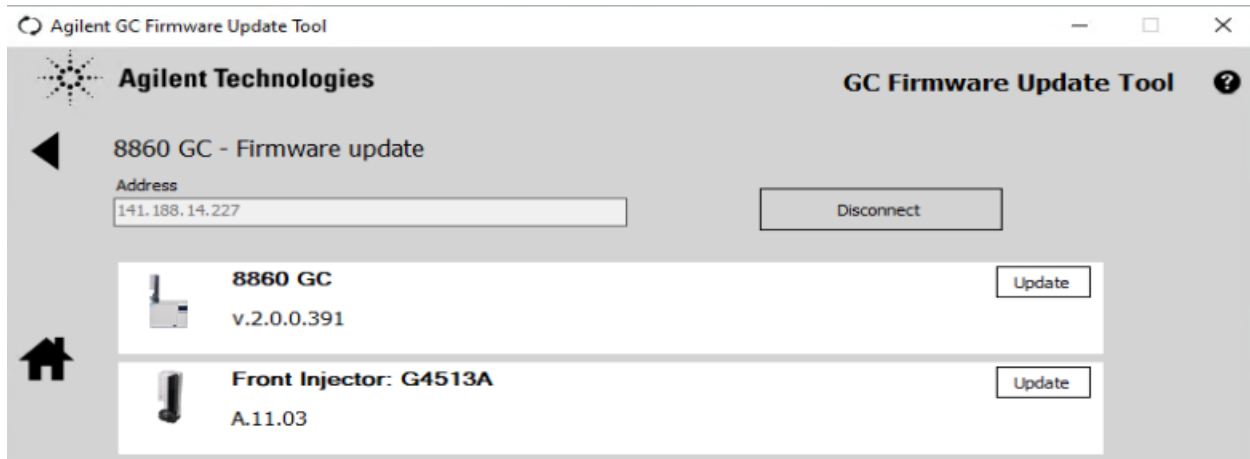
Press **Update**.

A Windows Explorer directory will then appear, and you must select the firmware revision that needs to be downloaded.
