## GC Troubleshooting Series Part Four: Tailing Peaks

**Daron Decker** is a GC Applications Specialist for Agilent's Columns and Supplies Division. **Herb Brooks** is an Agilent service engineer.

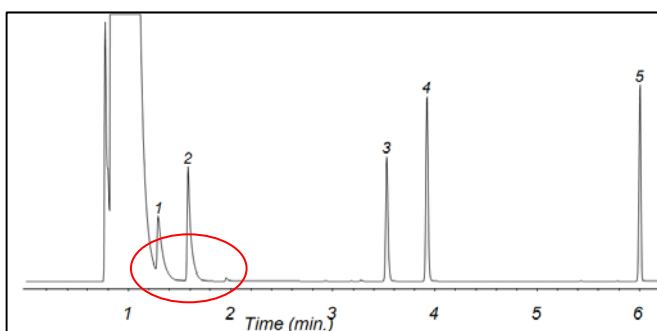
Routine inlet maintenance is essential to preventing issues like tailing peaks.

- 1) Inlet contamination. Do basic inlet maintenance: replace the liner, the o-ring, septa, possibly the gold seal. Consider sample prep or filtration to prevent the issue from re-occurring.
- 2) Column activity. Trim the column, or replace the column if trimming doesn't solve the issue.
- 3) Column blockages – try injecting hexane or butane, which shouldn't have any tail. If they do tail, you know you have a blockage.
- 4) Poorly installed column. Try re-installing.
- 5) Solvent polarity mismatch.
- 6) Reverse Solvent Effect.
- 7) Solvent effect violation. Decrease your initial column temperature by 10 – 20 degrees to address this.
- 8) Split ratio too low: you will want a minimum of 20 mL/minute of total flow through the inlet.
