Application News

An Example of Observing Reduction Gear Using the Microfocus X-Ray CT System

This article introduces an example of observing and analyzing the interior of a reduction gear using the inspeXio SMX-225CT FPD HR Plus Microfocus X-ray CT system.

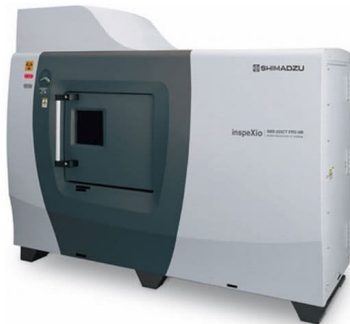
Fig. 1 inspeXio™ SMX™-225CT FPD HR Plus

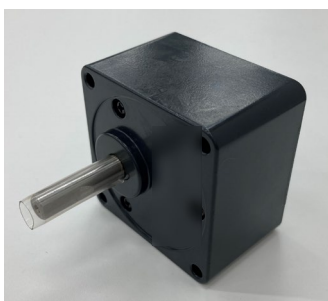
Fig. 2 External View of the Reduction Gear

In this case, a parallel shaft reduction gear of size about 60 × 60 × 70 mm was imaged, as shown in Fig. 2. Its interior was composed of parts, such as a housing, gears, bearings, and shafts. All these parts were made from metal, so high-intensity X-rays were required to observe their interiors. The main imaging conditions used are shown in Table 1. In this case two patterns of CT imaging were performed, overall and magnified. Their respective fluorescent images are shown in Fig. 3.

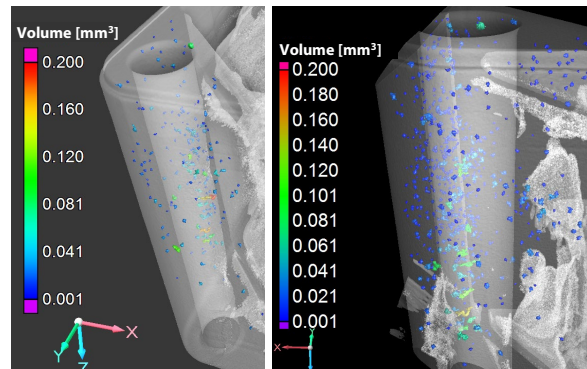
Fig. 9 Analyzing the Presence of Defects (Left: Overall Image, Right: Magnified Image)

In the cross-sectional view shown in Fig. 4, the presence of porosity is confirmed close to a bolt hole in the housing. Therefore, both the overall image and the magnified image data were analyzed for the presence of defects. This analysis can be performed automatically with just a simple setting, so the size, position, and number of pores can be easily determined. Fig. 9 shows an example of analysis in which the volume of pores is indicated by color.

Comparing the number of pores, 149 were detected in the overall image, and 285 were detected in the magnified image. The minimum pore size was $8.2 \times 10^{-3} \text{ mm}^3$ in the overall image and $4.4 \times 10^{-3} \text{ mm}^3$ in the magnified image. As can be seen from Table 1, the resolution is higher in the magnified image, and it is possible to detect porosity in more detail.
